Semi-permanent restoration in anterior tooth region rehabilitation – planning and implementation

Prof. Dr. Dr. Andree Piwowarczyk
Matthias Sieger

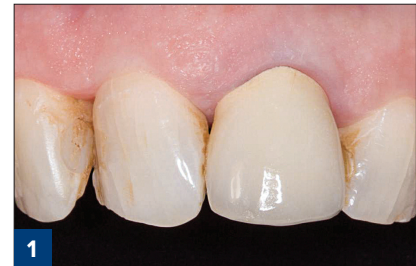
- Fig. 1 Inadequate metal-ceramic crown on tooth 21, labial view
- Fig. 2 Wax-up of tooth 21 on the diagnostic cast
- Fig. 3 Sectioning the ceramic veneer through to the crown framework
- Fig. 4 Chamfer preparation of tooth 21, with a circular preparation margin design
- Fig. 5 Preparation of tooth 21, maintaining a correct preparation geometry
- Fig. 6 Bubble-free filling of the drawn-down template with LuxaCrown
- Fig. 7 Intraoral positioning of the template filled with LuxaCrown
- Fig. 8 Semi-permanent restoration remaining on the prepared tooth immediately after removal of the template
- Fig. 9 Initial try-in of the semi-permanent restoration after marginal shape correction
- Fig. 10 Final fixed semi-permanent LuxaCrown restoration

In the special medical history the patient indicated that the metal-ceramic crown on abutment tooth 21 was approx. 30 years old. In this inadequate restoration with a mismatched color, a dark bluish grey discoloration was visible in the region of the marginal gingiva. A root filing and metal post were discovered on the x-ray. After creating diagnostic casts the patient was informed and then pre-prosthetic orthodontic procedures as well as potential treatment options discussed. In agreement with the patient a decision was made to restore tooth 21 with a full-ceramic crown. As part of a diagnostic wax-up, the form and position of crown 21 was altered using esthetic wax, taking into account functional and esthetic parameters (Fig. 2). Even as early as this phase the patient was able to get an impression of the future prosthetic restoration and influence the final outcome. In order to achieve a plannable outcome, a drawn-down template was created as a means of producing a semi-permanent restoration. The crown on tooth 21 was carefully sectioned using a diamond bur on the ceramic veneer and a crown cutter protecting the marginal gingiva (Fig. 3). After removing the crown, a core build-up and metallic post became apparent. The insertion of a new light-cured composite restoration served as a pre-requisite for the preparation of tooth 21, which was carried out using a circular preparation margin design with a chamfer as a demarcation line (Fig. 4 and 5). A silicone key was used to check that enough buccal substance had been removed. Once the shade was determined (A2), the template was filled (Fig. 6) – avoiding air bubbles – with LuxaCrown (DMG; Hamburg) and positioned in the patient's mouth (Fig. 7) in order to produce the semi-permanent restoration for tooth 21. After a setting time in the mouth of approx. 2 min, the restoration remained on the tooth (Fig. 8) once the drawn-down template was removed. The oxygen inhibition layer was removed with alcohol. The restoration underwent finishing with a cross-cut bur in the crown margin and proximal area approx. 5 min after the start of mixing. During the initial try-in (Fig. 9), the restoration was marginally altered in terms of form in the length of the incisal edge and the interincisal
